**Flood Control Project Maintenance  
Levee Inspections**  
**LMA District Cover Sheet**  
**Spring 2019 Levee Inspection Results**

**Reclamation District No. 0900 West Sacramento**

**Levee Inspection Report By Mile - Spring 2019**

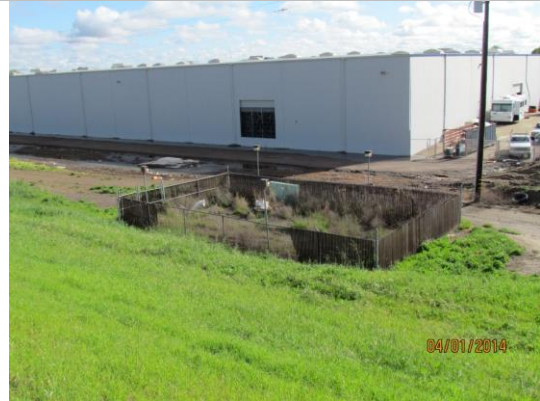
Photo 1 of 1 : SP\_2019\_RD0900\_231\_5\_20190307\_00001.jpg

LM Start	1.31	Rating **	M	Issue No.	5
LM End	1.31	Issue Type +	En	Location *	LS
Category	Earthen Levee			GPS Latitude/Longitude	
				Start	End
Item	Encroachments			38.569258 °	38.569258 °
				-121.582232 °	-121.582232 °
DWR ID	DWR_RD0900_02_s _ 2012_5				
Comment Code					
BU : Building					
Inspector Comment					
Abandoned city water well at the landward toe.

View of the water well on the landside toe of the levee looking upstream.

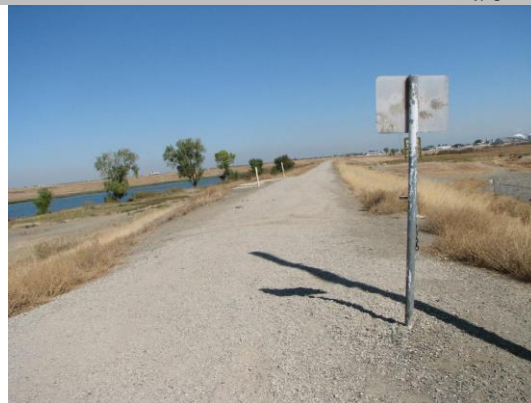
Photo 1 of 3 : UCIP\_SP\_2019\_37770\_68626.jpg

LM Start	3.23	Rating **	M	Issue No.	70
LM End	3.23	Issue Type +	En	Location *	
Category	Supplemental			GPS Latitude/Longitude	
				Start	End
Item	DWR UCIP Field Study			38.541353 °	38.541353 °
				-121.582202 °	-121.582202 °
DWR ID	17885				
Comment Code					
Inspector Comment					
FS_ID:37770 DS_ID:17885 EP_NO: 17070 Repair Type: Non-Urgent Crossing Status: Found UCIP Comments: Dense vegetation limits the inspector's visibility to identify signs of pipe failure (leaks) along the slope. Recommend removing vegetation along pipe alignment to conduct proper inspection of structure. FIELD_STRUCT_DESC: [Southport Business Park Storm Water Pump Station] 1 of 5. 30-inch steel drainage pipe through the levee, 2 feet below the levee crown. (12-inch pipe and four 30-inch pipes authorized under Permit No. 17070, 2000 - Reclamation District No. 900) FS Date: 10/5/2009

View of levee crown at crossing.

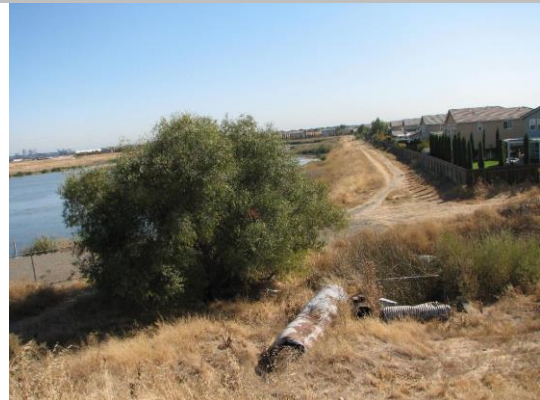
Photo 1 of 3 : UCIP\_SP\_2019\_37785\_68693.jpg

Comment Code					
Inspector Comment					
FS_ID:37785 DS_ID:17856 EP_NO: 2721A Repair Type: Non-Urgent Crossing Status: Found UCIP Comments: Need to contact owner--crossing appears to no longer be in use. Abandoned pipe sections visible on landward side and damage to pump station on waterward side. FIELD_STRUCT_DESC: [Drainage Pump Station] 36-inch corrugated metal irrigation pipe through the levee, 3.0 feet below the levee crown. Pump house and siphon breaker are located on the on the waterside (WS). (two 30-inch pipes at location 1, HLM 1.05, (drainage pump) and 36-inch pipe at location 2, HLM 3.68, (irrigation pump) authorized under Permit No. 2721A - Reclamation District No. 900 [RD0900]). [Additional Reference(s): DWR Levee Log, 2003] FS Date: 10/5/2009

View of pipe sections visible on landward side.

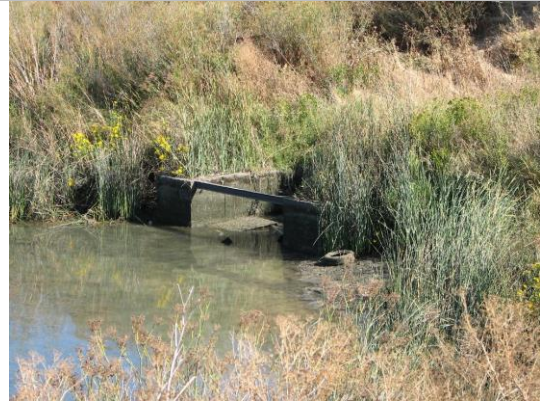
Photo 2 of 3 : UCIP\_SP\_2019\_37785\_68692.jpg

Concrete outlet visible on waterward side.

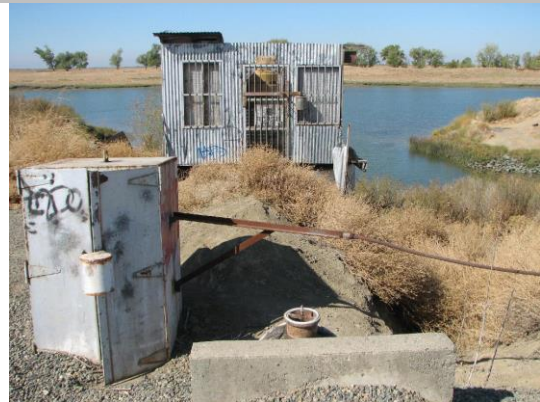
Photo 3 of 3 : UCIP\_SP\_2019\_37785\_68691.jpg

View of pump house visible on waterward side.

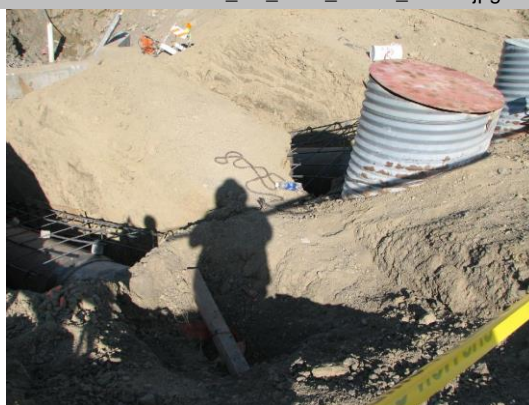
Photo 2 of 3 : UCIP\_SP\_2019\_37890\_68940.jpg

Construction of structures in Oct-2009, photo 2 of 3.
